Continued: Consumer Interview and Vehicle Inspection, ODI 10189655

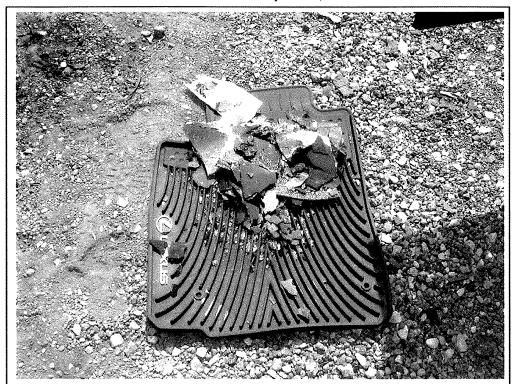
Photo 15: Driver all weather mat removed from vehicle

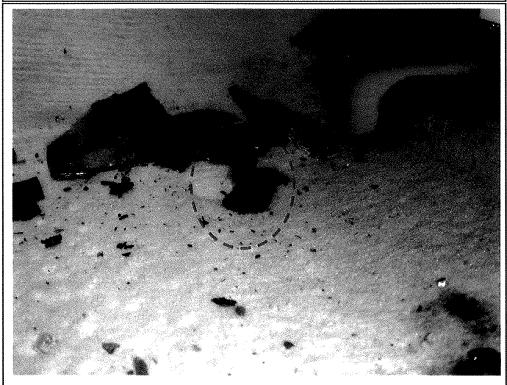
Photo 16: Driver inboard mat retention hook engaged in floor material
